McBride's Inspection Services Inc.
28947 Willow Creek Road
Eugene OR 97402
541-485-0125
mcb_inspections@clearwire.net

Report: Example Residential Address:

Confidential Inspection Report

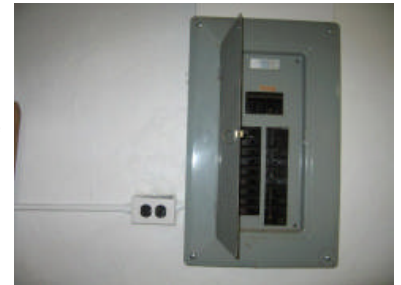
5.3 Main Panel Location:	p	Garage, Appears serviceable.
5.4 Main Panel Observations:				Circuit and wire sizing correct so far as visible, Grounding system is present, Multiple wires are connected to a single lug on a circuit breaker where only one wire should be connected, Missing strain relief at panel, Have a licensed electrician make further evaluation and corrections as needed.

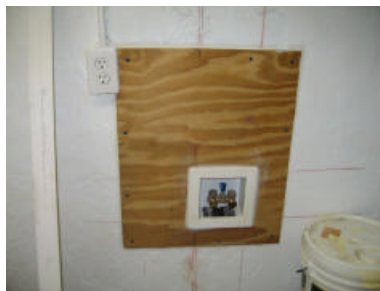
- 7.4 Laundry: p

Plumbing appears serviceable, but also appears handyman installed.

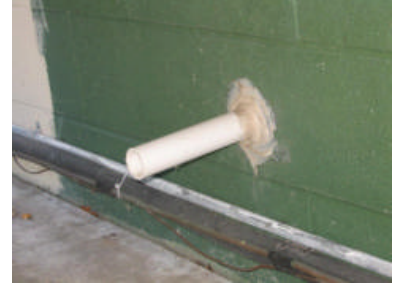
7.5 Laundry:

There is no trap on the drain line. Drain line empties into the rear yard and is considered a sanitary nuisance by local officials. Consider connecting this drain lin to the main drain system serving the house.

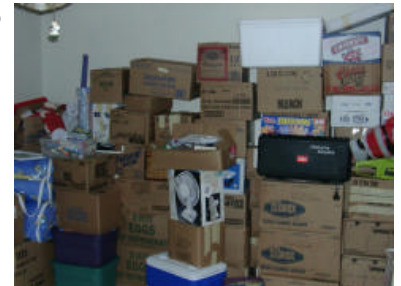
9.5 Kitchen Interior: Due to stored items in the closet, it is not possible to determine the condition of the walls and the ceiling that are not visible.

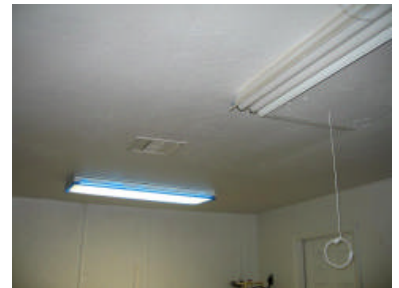
OK	MM	RR	
11.3 Condition:	p	"	"	Blemishes noted. Cosmetic repairs and trim needed to improve appearance.

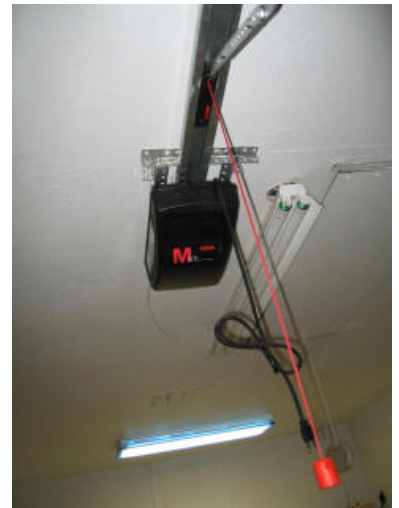
11.5 Door Operator:	"	"	p	Automatic door opener(s)- not operational, due to a lack of power. An electrical outlet should be installed in the ceiling.
---------------------	---	---	---	---
